#### SUMMARY

#### VERSEFX PROJECT

## REPORT ON JUNE-JULY ACTIVITIES:

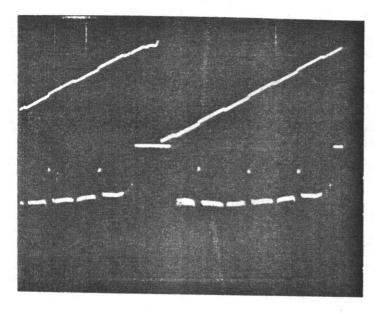
F16.2.

- A. At low levels, the video noise is proportional to the first order derivative of the scanning noise (6db/octave).
- B. At higher levels, the video noise responds in a non-linear fashion to the scanning noise (photo no. 2). Noise peaks tend to be narrowed, while dark areas are wider.
- C. For a given scanning noise, the video noise level will be roughly proportional to the grey level, except for areas of CRT extreme non-linearity (black). As a result, the video S/N (always computed by reference to peak white) will always be better in dark areas of the picture.

proportional to spot velocity. As the velocity is proportional to the scanning frequency, a 6db/octave noise transfer wave is to be expected at low noise levels, and is confirmed by experience. At higher noise levels, the sawtooth begins to look like a staircase (figure no. 2) which explains alternations of white narrow peaks and large dark areas.

3. Video amplitude tracking. Figure 2 clearly shows the impracticality of open loop video amplitude tracking. This is confirmed by the poor performances of both Scanimate and System 4 in that respect. The VID board is to be considered as a very rough approximation of what is necessary, but fulfills an essential function of protecting the CRT from irreversible burn-ins.

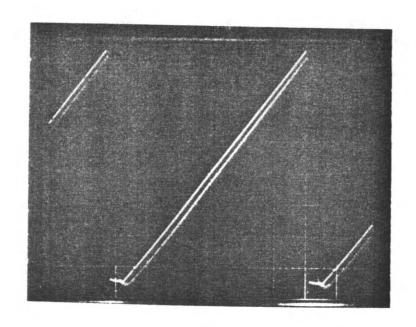
bandwidths as much as possible. 500KHz is a resonable compromise = good linearity, (even in the high resolution mode) acceptable rise time (lus) for the rarely used "hole punching" effect, and reasonable noise (photographs 5 and 6).

FIG 5. 15 KHZ SAW100TH WITH 200 KHZ LPF.

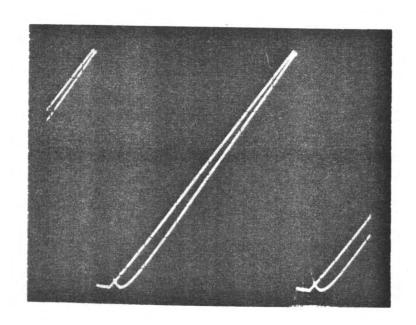
F16.6. 15 KHZ SAWTOOTH WITH 100 KHZ LPF.

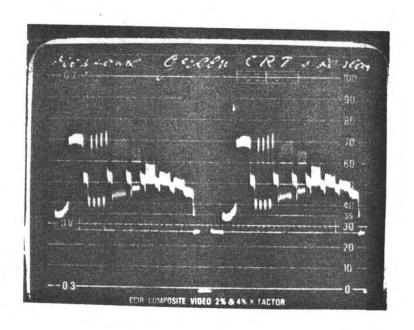
FIG 7. RESPONSE GREEN CRT.

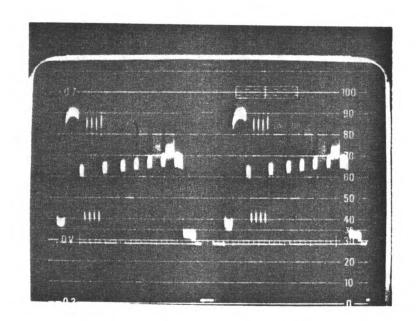
FIG 8. RESPONSE BLUE CRT.

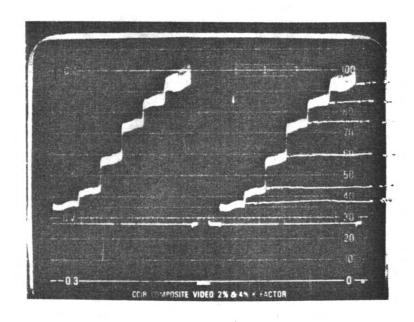
However, response, linearity, field uniformity and shading should be improved (figures 9, 10, 13, 14). Part of the problem is due to the fact that we are using an older CRT, and we did not want to replace it at this stage because of cost. Simple circuit hygiene and use of a new tube should make these performances adequate.

FIG 9. RESCAN LINEARITY.

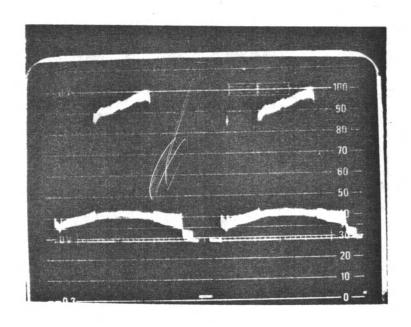
FIG 10. RESCAN H SHADING.

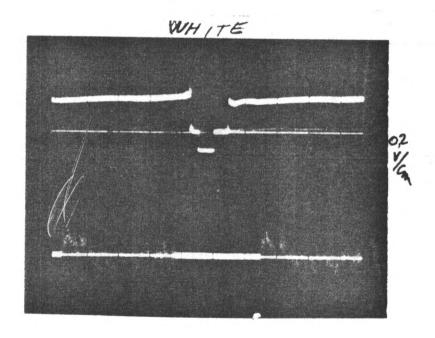
- A. <u>Documentation</u>. Quite insufficient. Schematics are either incomplete or out of date. I sugggest to select a single set of blue prints for schematics, update them by hand to reflect the present VerseFx status, then keep using this single set for continuing updating until the design is completed.
- B. <u>Rescan area</u>. Noise characteristics have been found adequate (figures 11-12).

FIG 12. WHITE RESCAN NOISE.

5/N = 45 DB

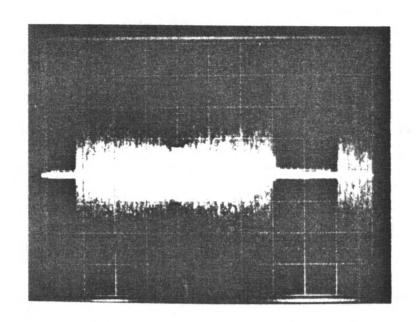
FIG 16. VFX OVERALL NOISE.

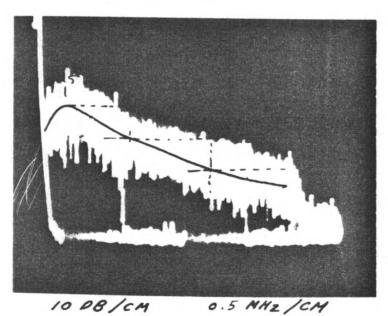
FIG IT. VFX NOISE SPECTRUM.

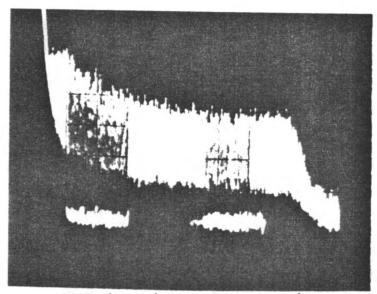
FIG 18. BLACK SPECTRUM.

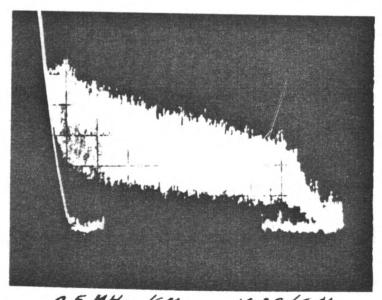
0.5 MHz ICM 10 08/CM FIG 19. WHITE SPECTRUM.

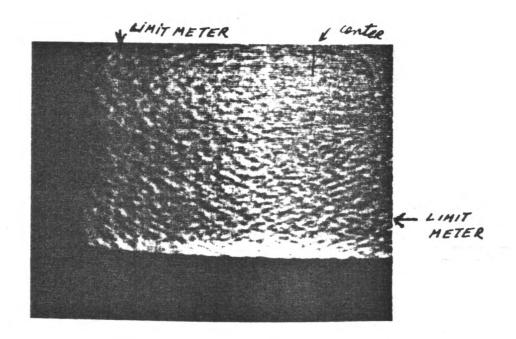
FIG 20. VFX.

WHITE FIELD \_ SCREEN APPEARANCE.

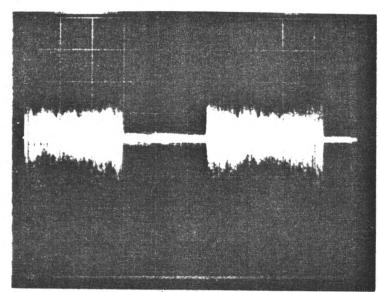
FIG 21. H SCANNING ONLY.

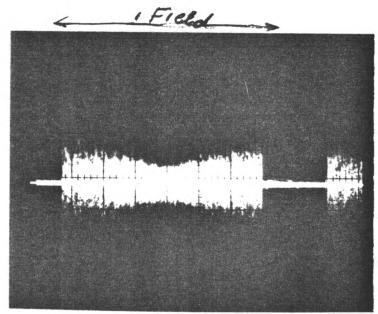
FIG 22. V SCANNING ONLY
NOISE.

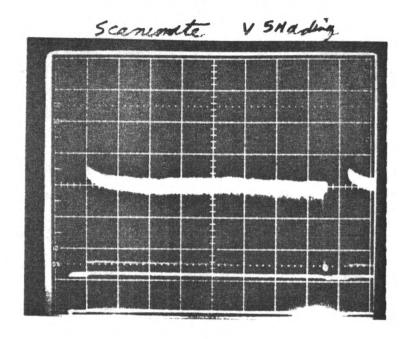
A full investigation of Scanimate has been carried out (photographs 23, 24-26, 32, 33) and its performances have been found surprisingly mediocre: 36db S/N, shading, low resolution, poor video intensity tracking.

FIG 26. V SHADING.

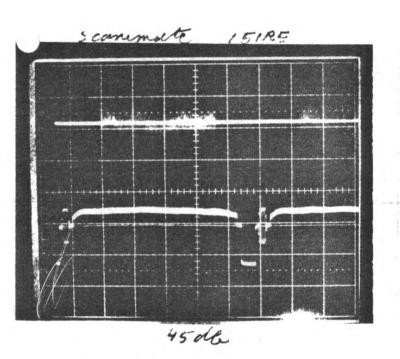
FIG 32. BLACK NOISE.

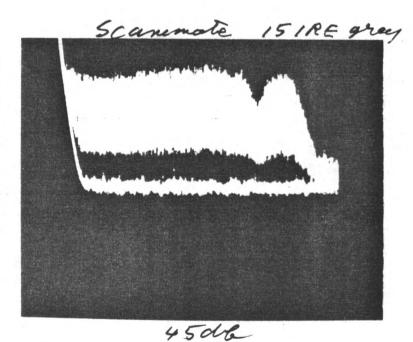
FIG 33. BLACK NOISE SPECTRUM.

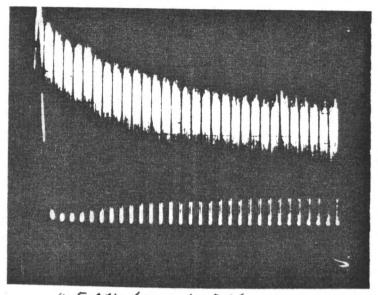
Furthermore, the bandwidth of these amplifiers (as utilized in VFX) is only 150KHz (figures 27-28) which is absurd as they follow a 10MHz multiplier.

05 MHz/CM 10DB/cM FIG 27, VCR V OUT. NOISE SPECTRUM.

<u>VCR.</u> 429 multipliers and HA2535 operational amplifiers are to be replaced by figure 38 building blocks.

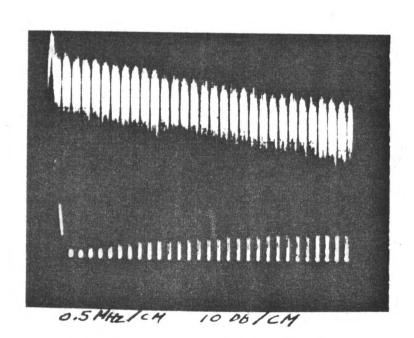
FIG 28 VCR V MULTIPLIER OUT. NOISE SPECTRUM.

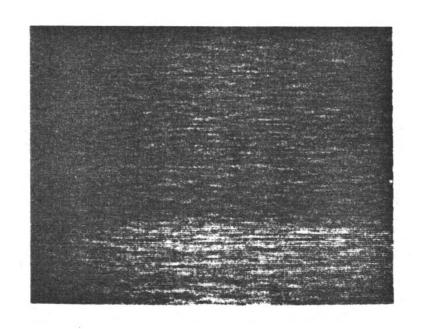
FIG 29. VFX SCREEN
NO PERSPECTIVE.

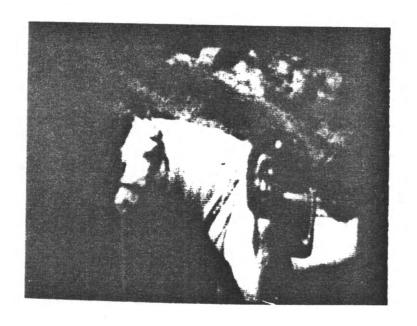
The overall VFX output S/N is 46db in the black areas and 43db in the white areas if only this new multiplier is used, and used only for vertical rotations (figures 30 and 31).

FIG 30, VFX OUT. VROTATION: +1

S/N BLACK = 46 DB

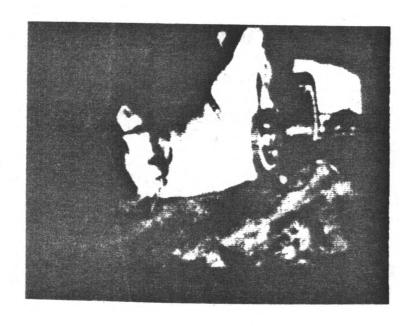
FIG31.VFX OUT VROTATION: -1

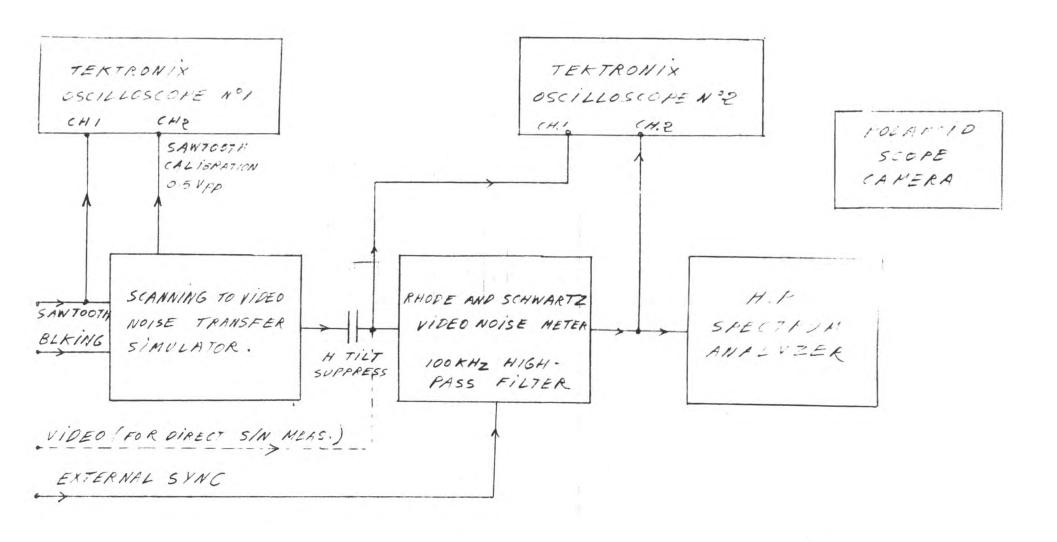
FIG 34. NOISE MEASUREMENT SET.UP.

Figure 34 shows the overall diagram of the set-up. Figures 35 and 36 represent the block diagram and the schematics of the scanning-noise to video-noise transfer simulator.

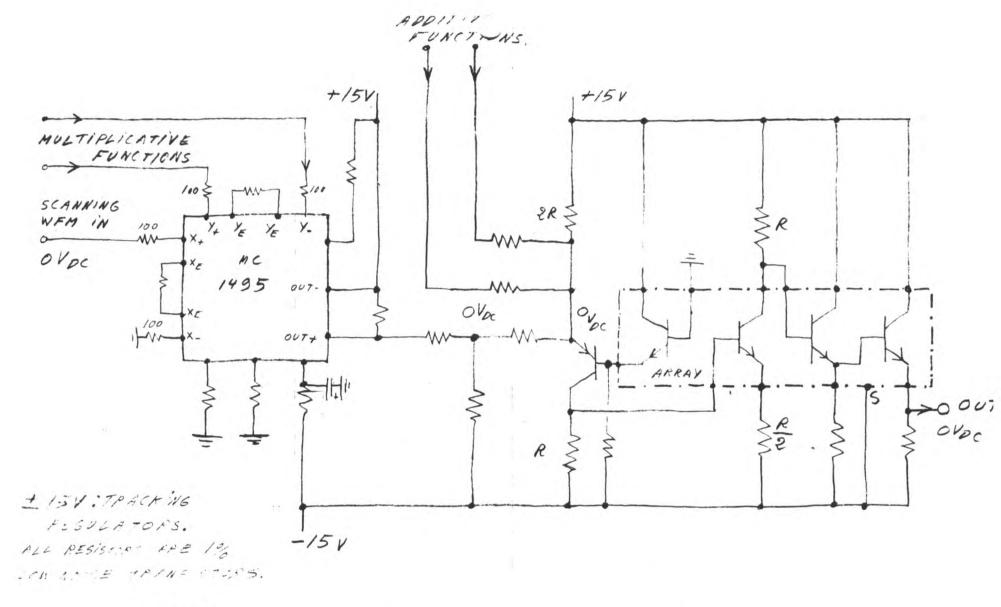
FIG 38. AN EXAMILE OF A LOW OFIFT, LOW NOISE,

To reach this goal, a low noise building block is presented on figure 38. This circuit should be capable of additive or multiplicative manipulations of a scanning waveform with a video-equivalent S/N better than 60db.

These figures are nearly acceptable. It is not obvious whether the structure should be drastically modified or not. The best course of action is to attempt to live with the present ramp generators, replace op-amps by our noise-free adder (figure 38) and replace the multipliers by MC1595 types. All connections to and from the analog section are to be shielded and power supplies are to be decoupled (these conditions apply for all three boards).

VRM. Our experiments with the present structure only allow us to improve the 44-47db figures to about 47-50. Furthermore, when a rotation takes place, three multipliers are being used in each channel, and the final S/N may be even lower. 429 multipliers and HA2535 operational amplifiers are, therefore, to be replaced by figure 38 building blocks. Shielding of analog circuits and connections is required.
